TITLE OF THESIS FATIGUE STRENGTH OF TWO STEEL DETAILS

DEGREE FOR WHICH THESIS WAS PRESENTED MASTER OF SCIENCE

FATIGUE STRENGTH OF TWO STEEL DETAILS

KAREN A. BAKER

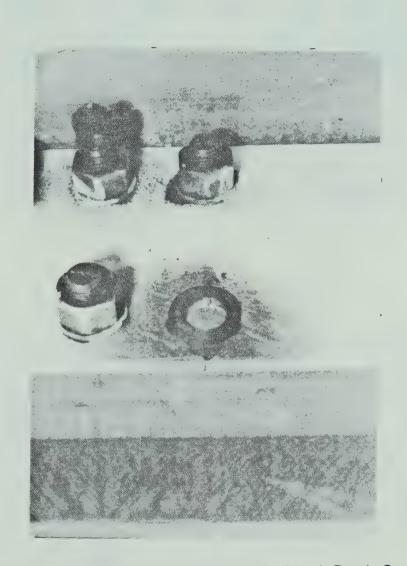
Figure 4.1 Failure Crack in Bolted Test Beam

In five of the six tested specimens, three with open holes and two with holes containing bolts, the crack initiation and growth patterns were similar. Initial cracking began at the extremity of one of the end holes and proceeded to grow out towards the flange tip (Fig. 4.1). Before the crack had progressed from the hole completely through to the flange tip, another crack started on the opposite side of the same hole and progressed in towards the web. In the sixth specimen, the crack started at the extremity of an interior hole and grew out towards the flange tip.

Failure was considered to have occurred when the dynamic deflection increased by 0.5 mm. The cracks generally had caused a reduction of 25 to 50% of the flange cross sectional area by this time.

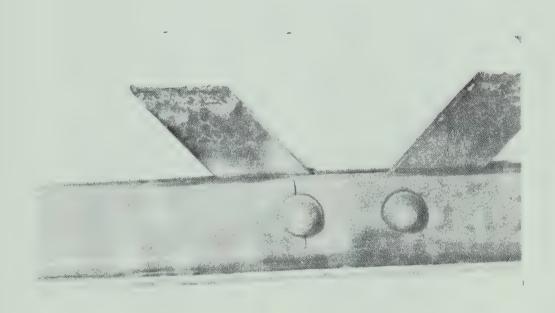
Figure 4.3 Failure Crack in Rivet Hole

In all of the specimens but one, the fatigue crack that developed grew normally to the applied stress at the extremity of the rivet hole and progressed out to the edge of the angle leg that contained the rivet. Before this crack had progressed completely to the edge another crack started from the opposite side of the same hole and moved in towards the corner of the angle. Figure 4.3 shows a typical fatigue

crack in a rivet hole. The exception was a failure at a flaw on the edge of an angle leg where the surface had been ground to reduce the size of the specimen. This was not included in the results. It should be noted that three other failures at rivet holes occurred in the same specimen before a failure crack was initiated at this flaw. A fractographic and microstructural analyses were performed on one of the specimens that had a fatigue life shorter than some of the others. A section was made perpendicular to the plane of the crack in the rolling plane. It was then ground, polished, etched with nital and examined. Nothing out of the ordinary was found. The steel had a carbon content of 0.2%, many non-metallic inclusions, and was considered dirty by modern standards.

At failure, the cross section had been reduced by 30% to 100%. Since the fatigue crack begins at the hole it cannot be seen until it grows beyond the rivet head. Cross sections which were reduced by 100% were the result of the tests being run 24 hours a day. However, in most cases the test was stopped when one angle of the pair fractured. It should be noted that riveted built-up members provide redundancy; a crack that forms in one component cannot directly grow into one of the other components in the structure.

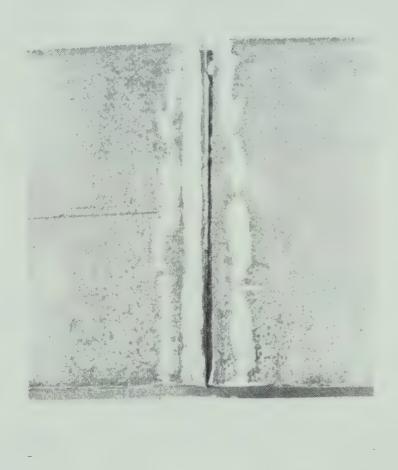
Figure 7.1 Failure Crack in Groove Weld with Backing Bar Specimen

In all of the groove weld with backing bar specimens the cracks initially began on the top surface, the same surface as the flush ground groove weld, in the center region of the plate width. This indicates that the center portion of each plate was probably a region of residual tensile stress. From the initiation site the cracks grew horizontally in both directions across the width of the plate and downward towards the backing bar. Upon examination of the failure surfaces it was apparent that the cracks started at a flaw and grew as a semi-ellipse. The cracks continued to grow semi-elliptically until the crack had propagated about 4 mm down through the thickness of the plate. At this time the cracks then grew as two-ended cracks until failure occurred. Failure was considered to have taken place when the dynamic deflection had increased by 0.5 mm.

In the three specimens tested at a stress range of 117 MPa all the cracks occurred along the edge of the groove weld in the heat-affected zone. At failure, the cracks had propagated to one of the edges of the plate (Fig. 7.1). The lengths of these cracks varied from 150 mm to 270 mm, or from 50% to 90% of the plate width. Two of these three specimens also had cracks throughout the length of one of the fillet welds used to attach the backing bar to the plate.
